## Wisenet Line-up Building the Perfect Security System for a Convenient Shopping Experience

### Challenge

### Solution

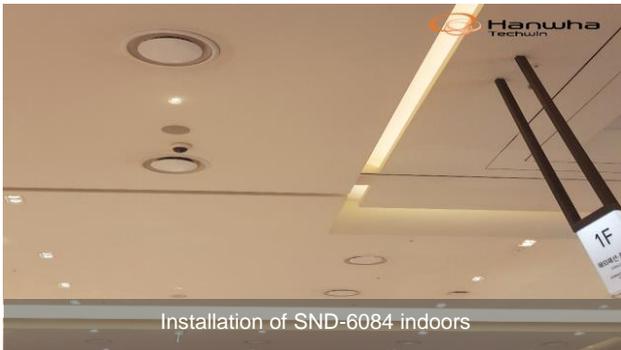
Installation of SND-6084 indoors

Being the largest department store in the metropolitan area, there are 1,110 cameras installed in the Hyundai Pangyo Store. The inside of the department store and the escalators, which pose a higher risk of theft, loss and accidents, have been designated as key areas to be monitored, and SND-6084 were installed to enable clear, high-resolution video monitoring.

The SND-6084 is one of Hanwha Techwin's Wisenet III product line, boasting stable compression and transfer of high-resolution video in full HD. In particular, its advantage is that it provides a P-Iris and allows its users to see clear video of objects at both short and long distances.

SND-6084 were also installed in the department store's entrance, which posed a challenge as objects were not clearly distinguished in backlit situations caused by outside lights. SND-6084's WDR feature resolved this problem and enabled clear monitoring in all lighting conditions.

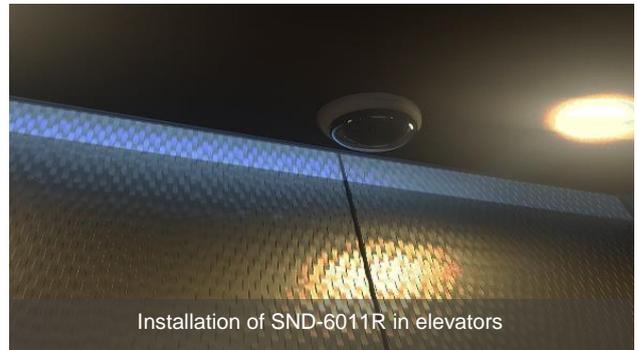
Installation of SND-6011R in elevators

SND-6011R from the Wisenet III line-up was also installed in the elevators within the department store. SND-6011R allows wide angle monitoring without blind spots even in confined spaces such as elevators, and is equipped with an IR LED to clearly identify objects in dark or low light conditions.

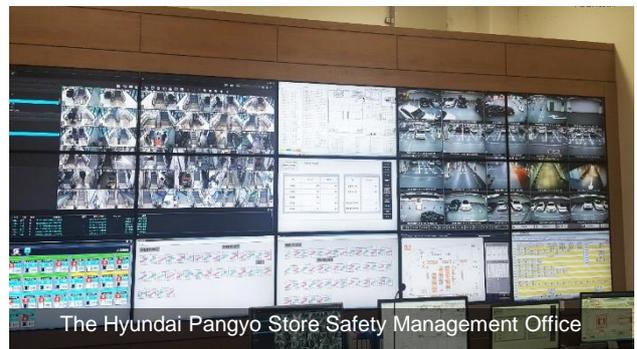
At the Control Center of the Hyundai Pangyo Store, rack-installed SRN-4000 units operated at full performance. The SRN-4000 is a network recorder capable of storing up to 64 channels of Full HD video in real-time. Such outstanding recording performance is crucial for monitoring the recorded data. SRN-4000 includes RAID 5/6 that increases its reliability due to its ability to restore data even if an HDD fails. It also includes a hot swap feature that allows for uninterrupted recording even when HDDs are being replaced. Moreover, its dual SMPS offers more power reliability as backup power can be used immediately in cases of primary power switch malfunctions. The integrated monitoring software SSM (Smart Security Manager) was crucial for efficiently managing over 1,100 cameras and network recorders within the department store. Through SSM, not only the operational efficiency of the entire security system was maximized, but event pop-ups were also generated whenever events occurred within the department store so as to make safety managers respond in a timely manner.
