Wisenet Line-up Building the Perfect Security System for a Convenient Shopping Experience

· Customer : Hyundai Department Store
 · Location : Pangyo, Korea
 · Vertical : Retail

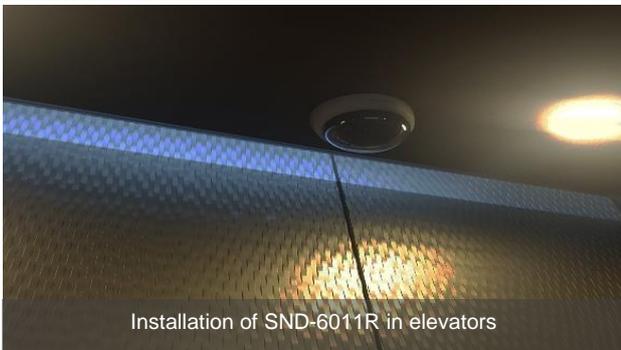
Installation of SND-6011R in elevators

video in full HD. In particular, its advantage is that it provides a P-Iris and allows its users to see clear video of objects at both short and long distances. SND-6011R from the Wisenet III line-up was also installed in the elevators within the department store to monitor confined space with lose lights.

SND-6084 were also installed in the department store's entrance, which posed a challenge as objects were not clearly distinguished in backlit situations caused by outside lights. SND-6084's WDR feature resolved this problem and enabled clear monitoring in all lighting conditions. SND-6011R allows wide angle monitoring without blind spots even in confined spaces such as elevators, and is equipped with an IR LED to clearly identify objects in dark or low light conditions. The Hyundai Pangyo Store is located in a key transportation hub that includes Pangyo Station on the New Bundang Line and the Pangyo toll gate, connecting Seoul and Bundang. The high traffic and fluid population required a camera with a high resolution and high powered zoom. SNP-6200RH provides a 20x zoom, enabling the close monitoring of areas around the store. After the actual installation, it was confirmed that the pavement on the roads surrounding the store could also be monitored clearly.
